The Use and Application of Composite Repairs

By Andrew J. Patrick

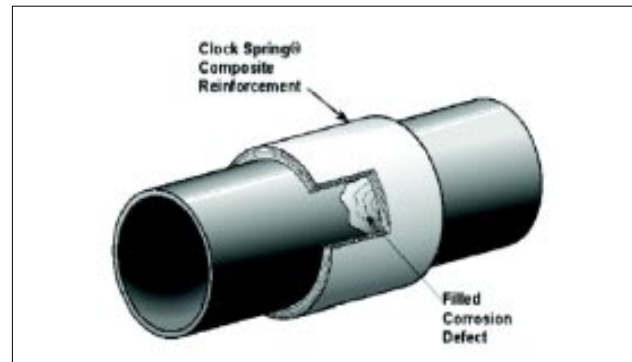
When applied to a non-leaking defect the composite repair works by sharing the hoop load in the pipe wall and controlling the rate at which the steel substrate yields. A cross section of a typical composite repair sleeve is shown below. In this particular instance a high compressive strength filler material is applied to the defect, this is then overwrapped with the composite repair sleeve and the

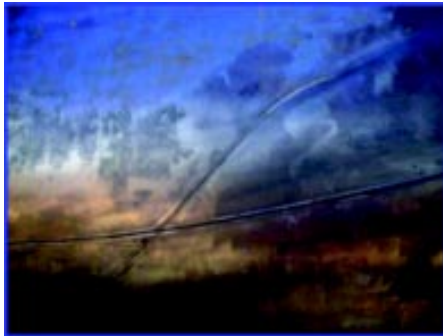
During a routine excavation an excavator accidentally hit a 28" main gas transmission pipeline causing significant mechanical damage of an 8 metre continuous section of the pipeline.

Figure 1 shows a portion of the total defect, the damage also extended through a girth weld on the pipe.

Fig 1 – Third party damage to the pipe wall.

In choosing the repair option the client determined the line could not be shut down and hot work was also not possible and therefore a decision made to utilise a composite repair. The client made a thorough study and evaluation of the range of composite repair technologies available, long term testing, testing of specific technologies for third party damage repairs and girth weld repairs following which the decision was made to utilise a full cure laminate repair composite sleeve system.

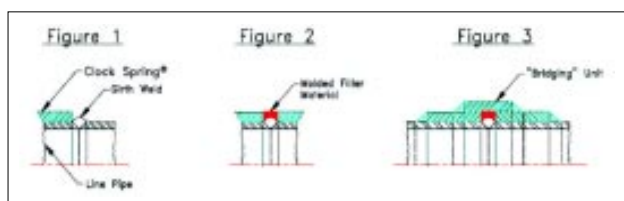
For the girth weld section a “bridging” technique was utilised as shown in the attached schematic.

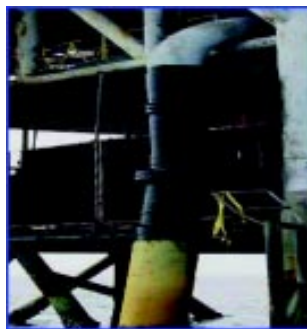
Fig 25 – Final coated and clamped riser repair.

Once installed the complete repair area including the holding clamps are sealed with a suitable corrosion coating Figure 25.
